Advanced Iso-Grid Fairing Qualification Test For Minotaur Launch Vehicle

Abstract: The development of the grid-stiffened fairing to be flown on the Minotaur launch vehicle has made significant progress over the past five years. During November and December 2002, this qualification structure was subjected to static qualification testing at the Air Force Research Laboratory (AFRL/VS) at Kirtland Air Force Base. The 6 m (20 ft) tall fairing was constructed of a carbon fiber composite grid structure that was over-wrapped to create a laminated skin. Upon completion of curing and machining, the fairing was cut in half to create the classic “clam-shell” fairing. Metallic joints were bonded and fastened to the fairing at all interfaces to complete the assembly process and simulate attachment of the base to a launch vehicle. Static qualification of the fairing tested the integrity of the fairing, thereby proving the design and manufacturing process. Loads were applied incrementally in a static loading scenario. The applied load envelope exceeded worst-case dynamic flight conditions with an added safety factor of 25%. At peak load the fairing must maintain structural integrity remaining wit

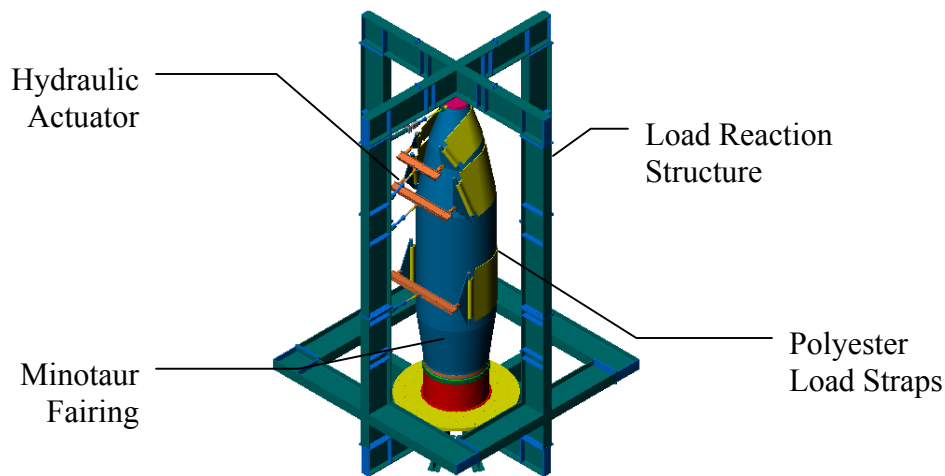
Figure 1. Test Configuration

The Minotaur Fairing Qualification tests were conducted in a general-purpose steel frame load fixture. The test fixture was used previously to flight qualify two separate payload adapter structures (EELV Secondary Payload Adapter (ESPA) for the EELV launch vehicle and a Multiple Payload Adapter (MPA) unit for the Minotaur launch vehicle). To suit the dimensions of the Minotaur fairing, the top cross bracing of the fixture was temporarily removed and an additional twelve feet of vertical column members were inserted at the four vertical uprights of Figure 1. The three lower lateral loads were applied by actuators to belts that were draped into position and gravity offloaded as needed to insure correct angle of load application. These belts distributed load to the fairing through 2 cm thick felt padding on the inside face of the belts. Aluminum spreader bars were provided to prevent contact of belt to fairing on the unloaded face of the fairing. Load angle was confirmed by multiple measurements with a digital inclinometer at 10, 20, 30 and 40 percent of design load. Typical frame to actuator connections and actuator to belt/nose plate connections are illustrated in Figure 2.

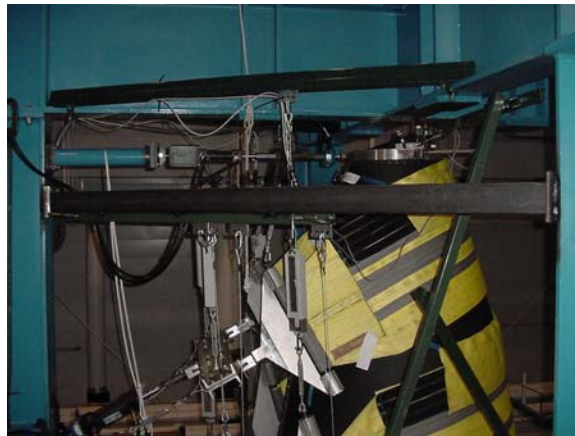
Figure 2. Typical Actuator Connections

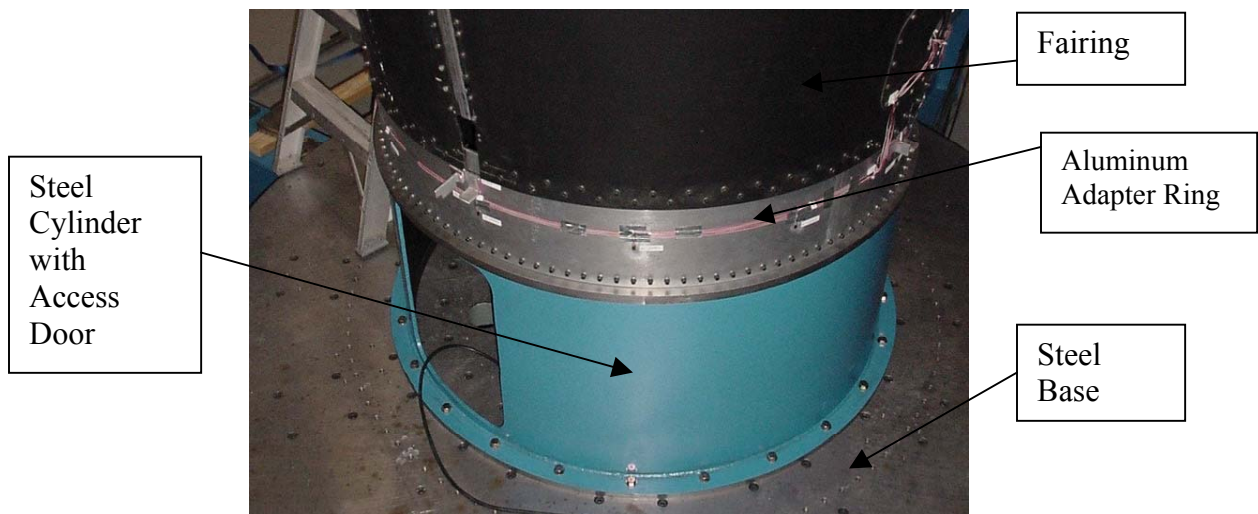
The load frame supported the fairing from below on a 3-meter diameter, 10 cm thick steel plate resting on steel I beams along 12 azimuths. A cylindrical steel structure containing a man-access port was bolted to the steel plate, a flexible aluminum ring consistent with the normal fairing attachment system for the Minotaur launch vehicle was bolted between the steel cylinder and the base of the composite fairing (see Figure 4). The access port in the steel cylinder was used to service the largest actuator loading the internal belt and to port all internal strain gage cables.

Figure 4. Support structure and aluminum interface

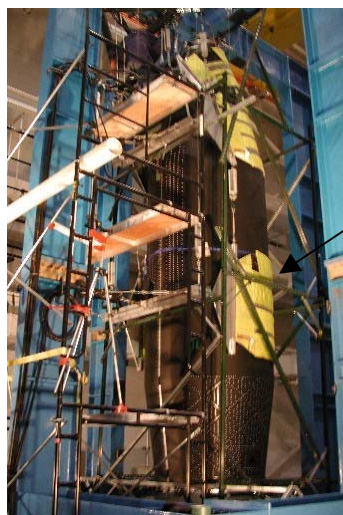
Displacement sensor structure

Typical Displacement sensor

Figure 5. Unistrut LVDT Support Structure

Each load test provided for 11 LVDT channels to monitor displacements at the base and nose of the fairing. At the base, axial and circumferential motions were measured at 0, 90, 180 and 270-degree azimuths from the direction of lateral load application. At the nose, circumferential displacements were measured at 90 and 270-degree azimuths from the direction of load application. Additionally one gage at 90-degree azimuth from the direction of load measured radial nose displacement. The sensors were supported from a Unistrut structure supported from the concrete floor of the laboratory and unattached to the load frame (see Figures 5 and 6).

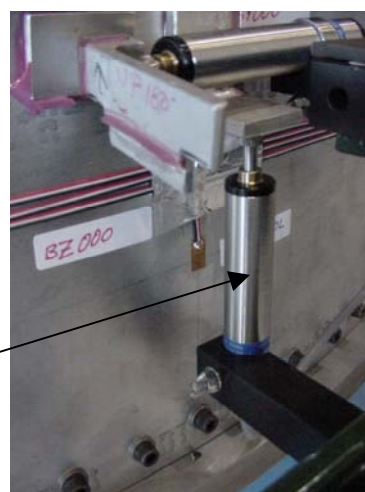
Figure 6. Typical LVDT Installation

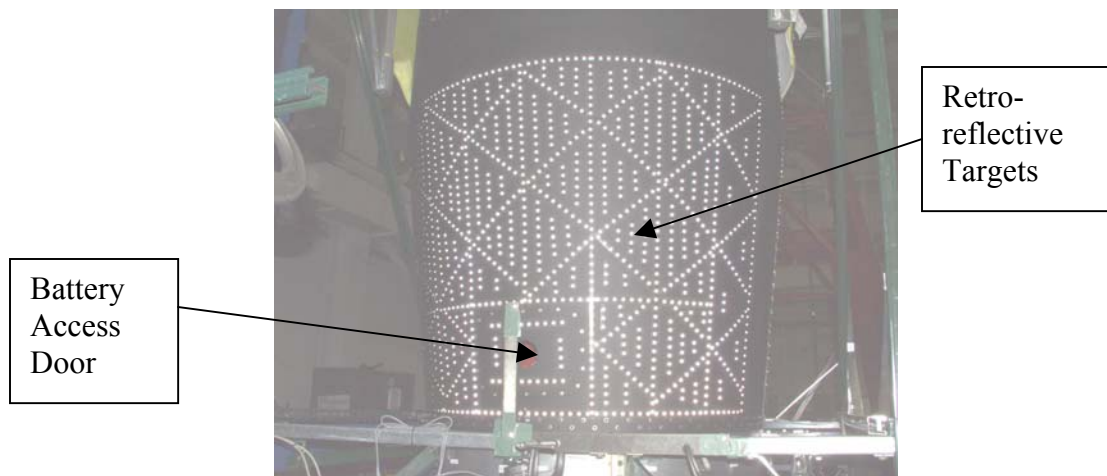
Three high-resolution digital cameras were located to capture a field of retro-reflective circular targets illuminated by the integral flash of each Olympus Camedia E-20 camera (see Figure 7). The target size and camera ranges were adjusted to provide effective sub-pixel target locations using PhotoModeler 4.0 software. The target locations provided by this software were used to assess radial motions of targets located over ribs and on the skin between ribs.

Figure 7. Retro-reflective Targets in Test 1 at Base of Fairing

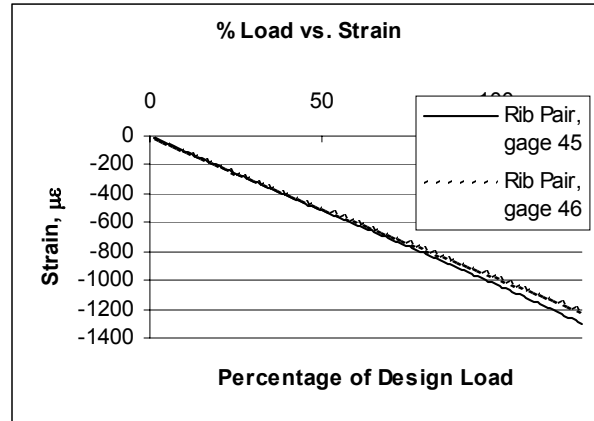
In reviewing the strain data for these tests, Figures 8 and 9 are quite typical of the type of linear response observed. These gage pairs were located on the most highly loaded compression ribs near the base of the structure. Very little bending is observed. The peak strain levels in Test 2 are about 40 percent low despite being position lower on the structure than the similar Test 1 gage. This reduced strain probably results from the compression plane alignment of the aluminum separation rail adjacent to this Test 2 gage and the thick composite pad-up at the rail to fairing connection.

Figure 8. Compression Rib Strain at Fairing Base—Test 1

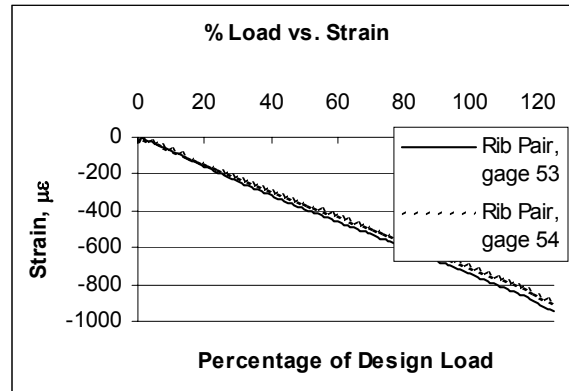
Figure 9. Compression Rib Strain at Fairing Base—Test 2

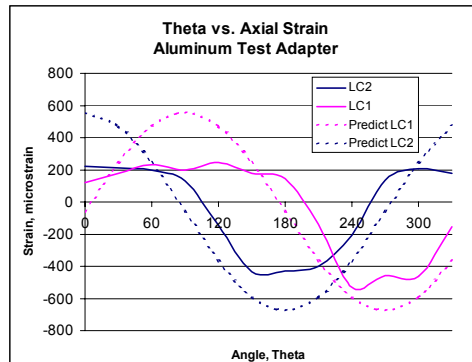
In Figure 10 the idealized strain gage readings for the aluminum support ring below the fairing base are compared to actual readings for both tests. Strain trends match predictions rather well despite the influence of axial rib peaking, probable bending about the circumferential orientations at the fairing to ring joint, etc. These results suggest good correlation between anticipated and actual load and response at the base of the structure.

Figure 10. Comparison of Predicted and Actual Strains at the Base Adapter

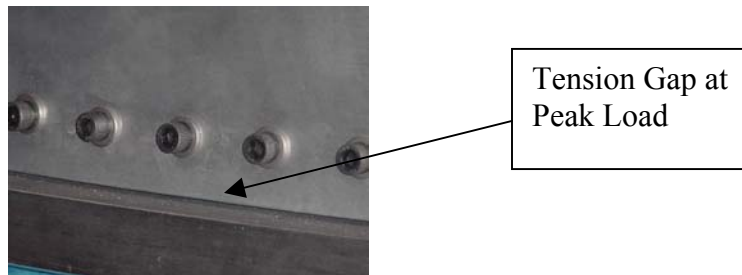
Figure 11. Bolted Joint Slippage at the Base of the Aluminum Ring

Predicted lateral deflections at the nose of the fairing were 2.69 cm (1.09”) and 2.31 cm (.91”) for Tests 1 and 2 respectively. As seen in Table 2, the actual displacements were about 40% to 60% greater than anticipated. In the Test 2 orientation, the added bending stiffness provided by the separation rails tended to reduce maximum displacements. Comparing axial LVDT measurements taken at the base of the fairing and noting a relatively large bolted joint slip in aluminum ring connection at the base of the fairing (see Figure 11), a determination was made that the lateral stiffness of the fairing was well within allowable tolerances. Also, no more than .013cm (.005”) of lateral nose displacement was seen in either test, suggesting good balance and minimal torque in the applied loads.

All of the major objectives of these two tests were satisfied. The fairing exhibited no distress of any kind, except for some minor popping noises at lower load level, which were attributed to slippage of bolted joints. Strain response was typically linear and within predicted values for both tests. Overall lateral displacement was within the allowable design criteria and very close to predicted values after giving consideration to unanticipated joint slippage at the base of the fairing.
